Failure Analysis of CCD Image Sensors using SQUID and GMR Magnetic Current Imaging

Frederick S. Felt

Failure Analysis Laboratory

NASA Goddard Space Flight Center

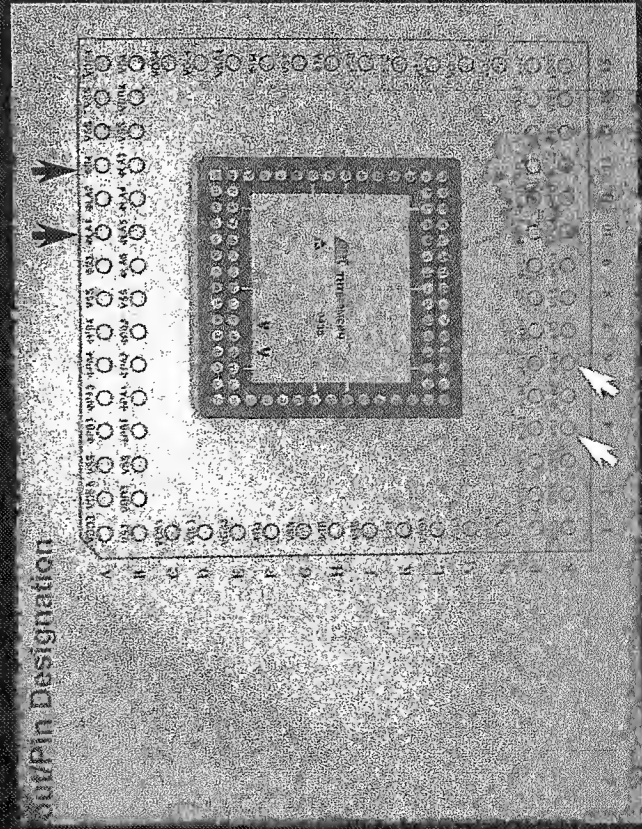
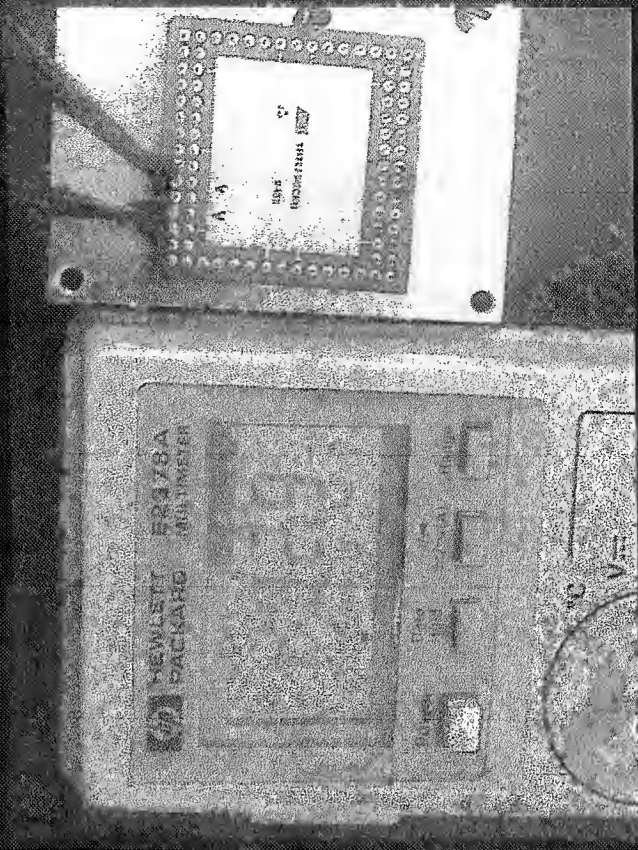
CCD Failures (SN06 and SN09)

- Ohmic shorts
- Between similar pins (SWA/B to LA/B1)
- Resistance: $E2\Omega < R < E3\Omega$

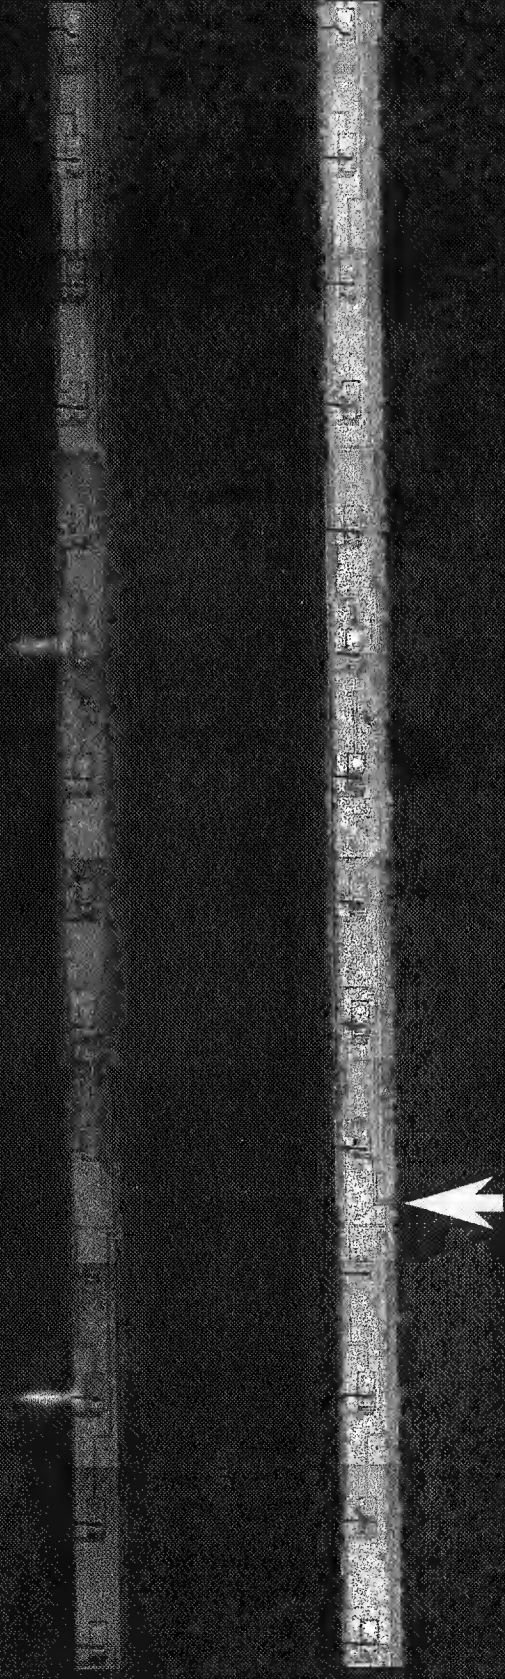
SQUID Current Map

- Overlay: current map and optical image
- Scan plane at 50 microns
- Ceramic package blocks scan at CCD corner

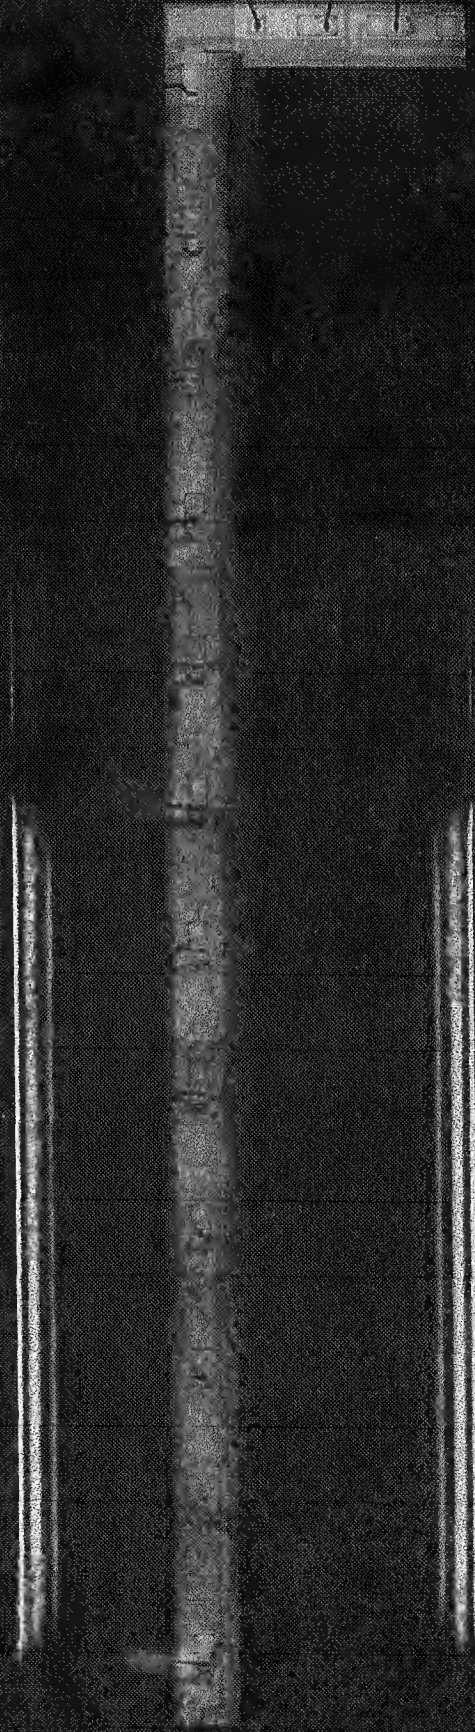
SQUID Current Map

- Scan plane increased to avoid ceramic package
- Resolution decreases
- Corner selected for GMR zoom

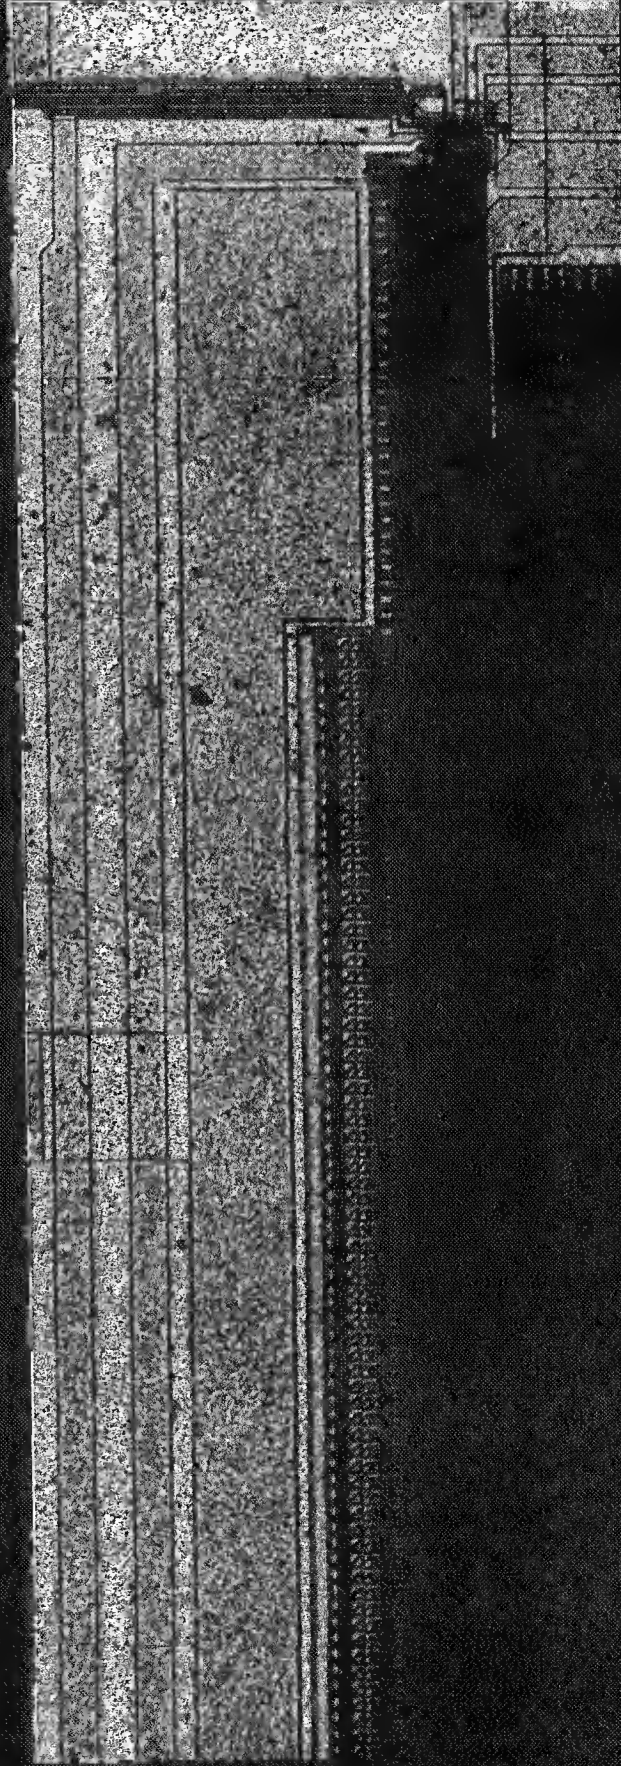
GMR Set-up and Current Map

- Probe contacts CCD surface
- 99 kHz frequency
- 2.0 mA current flow

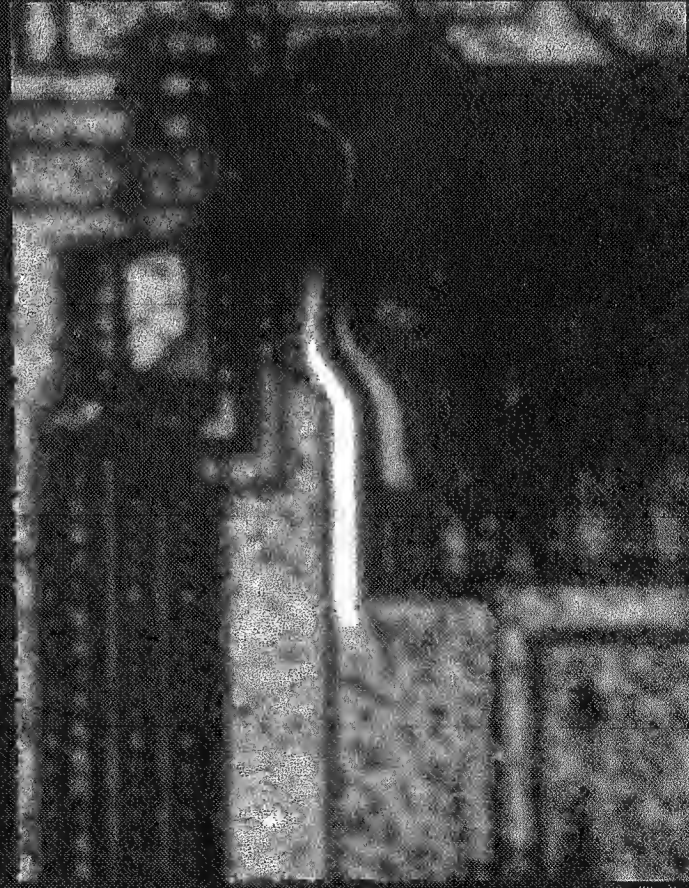
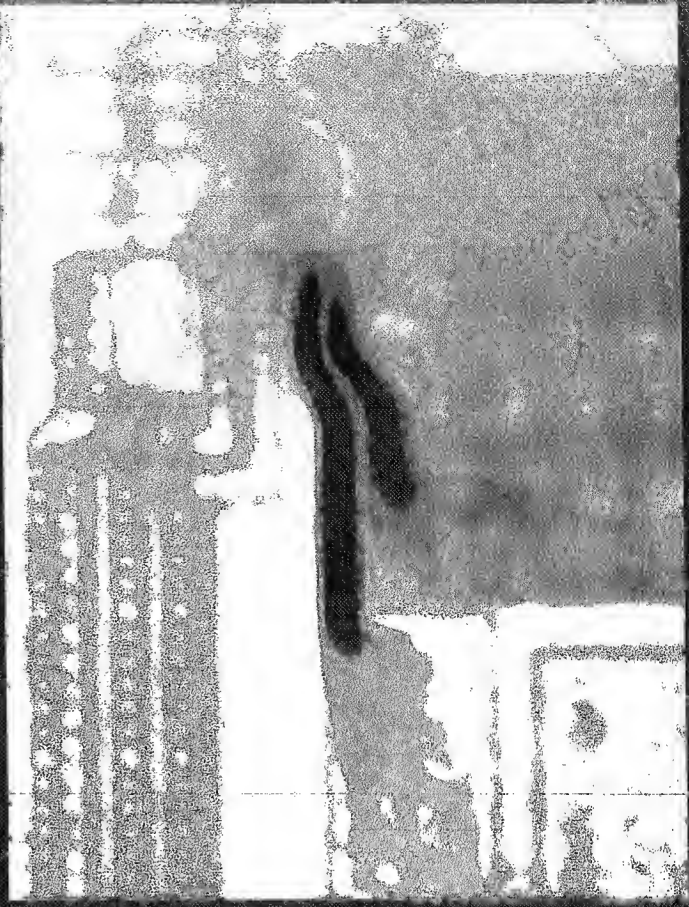
High-resolution GMR Scan

- Defect resolved to charge amplifier region with sub-micron resolution

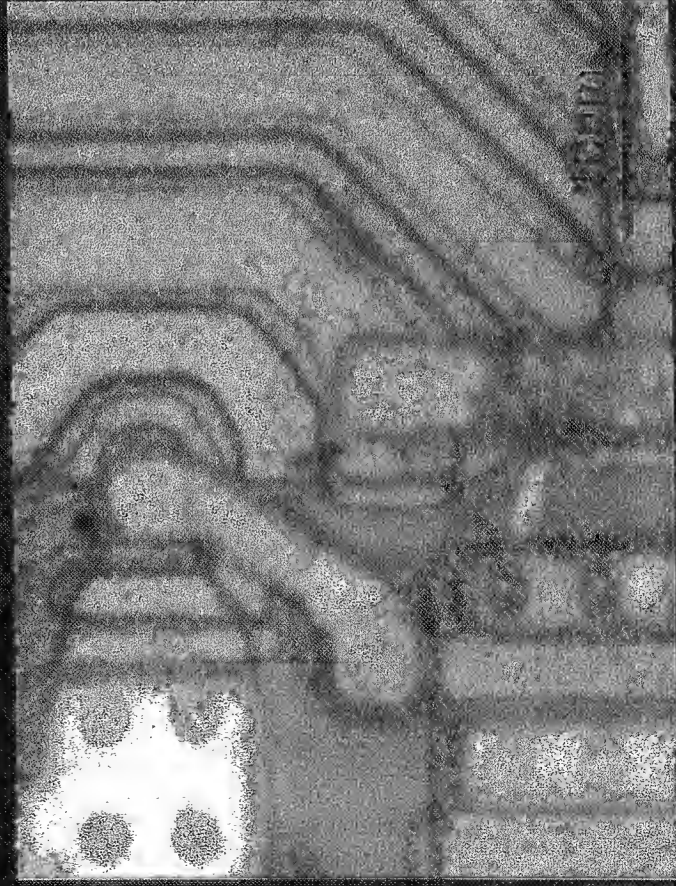
SN09

- Light shield removed by parallel polishing
- Optical inspection find anomalies

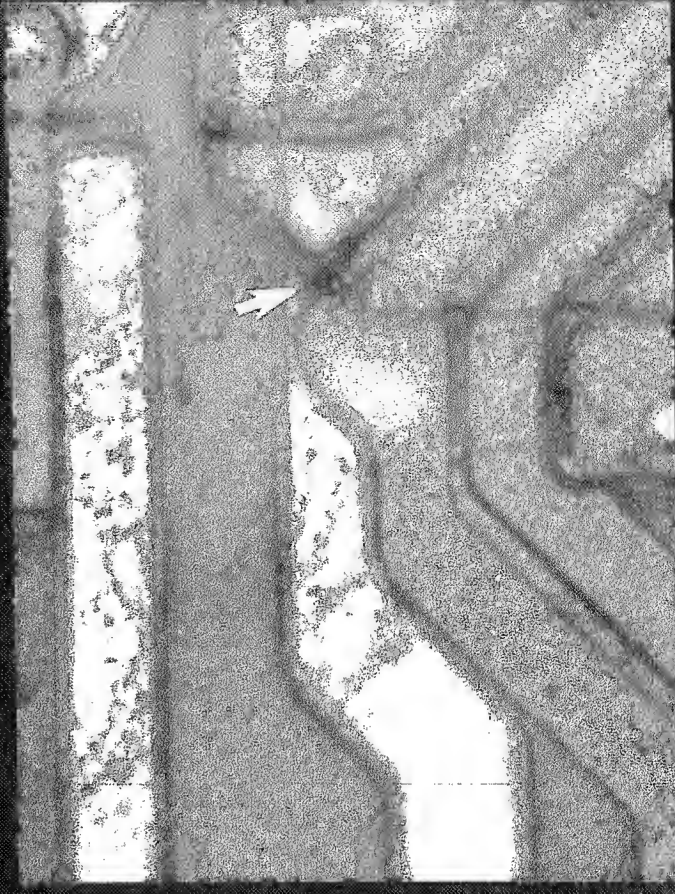
- Parallel polish CCD SN06
- InSb detector used
- Current of 5 mA and 10 mA
- No hot spot detected
- Defect possibly under M1 metallization

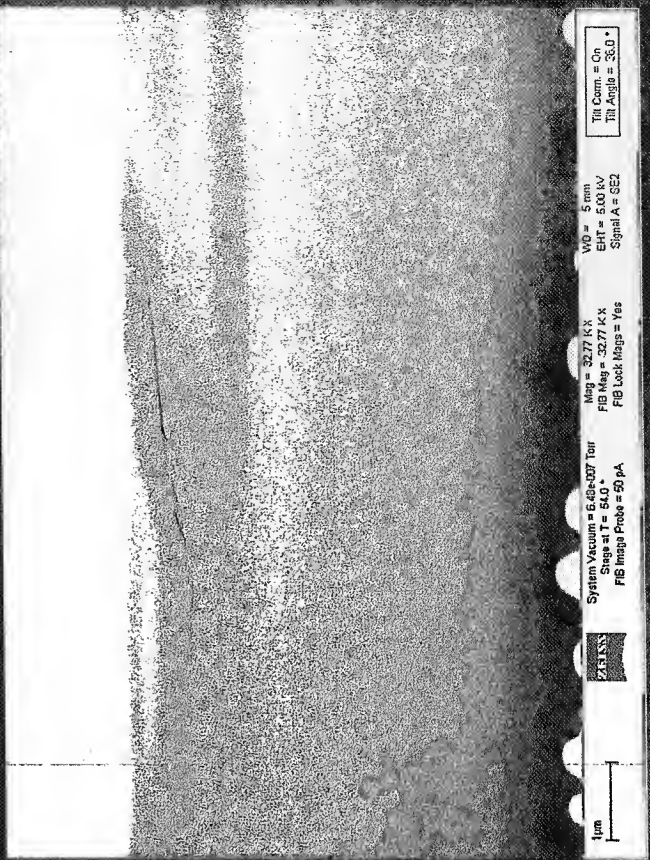
SWA/LA1 short L1

- SN06 FIB cross section
- Evidence of cracking, bridging

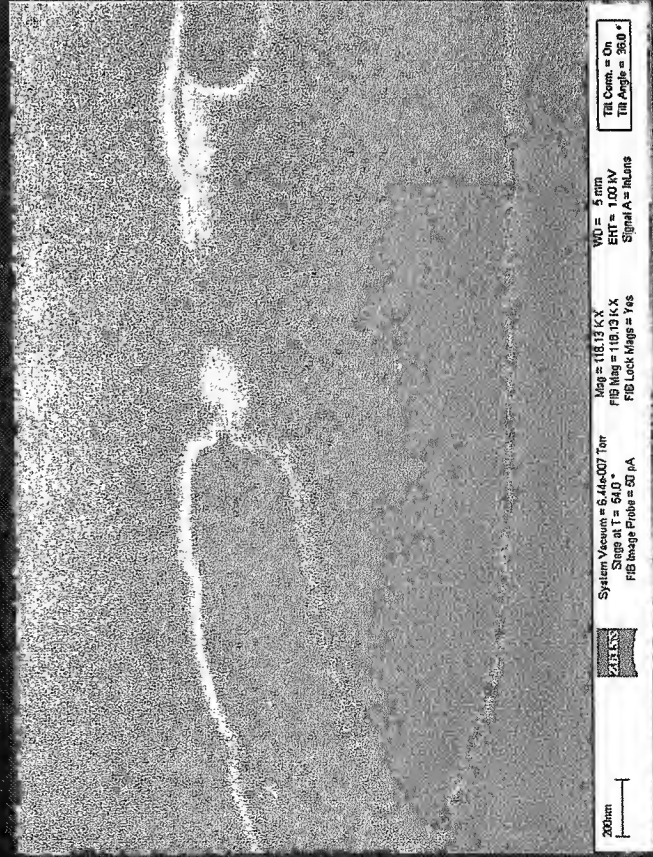
SWA/LA1 short L2

- SN06 FIB cross section
- Evidence of cracking, bridging

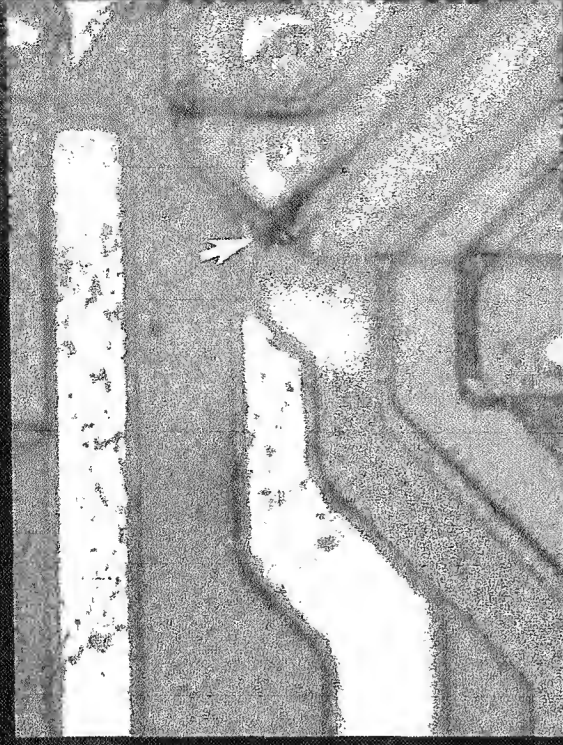
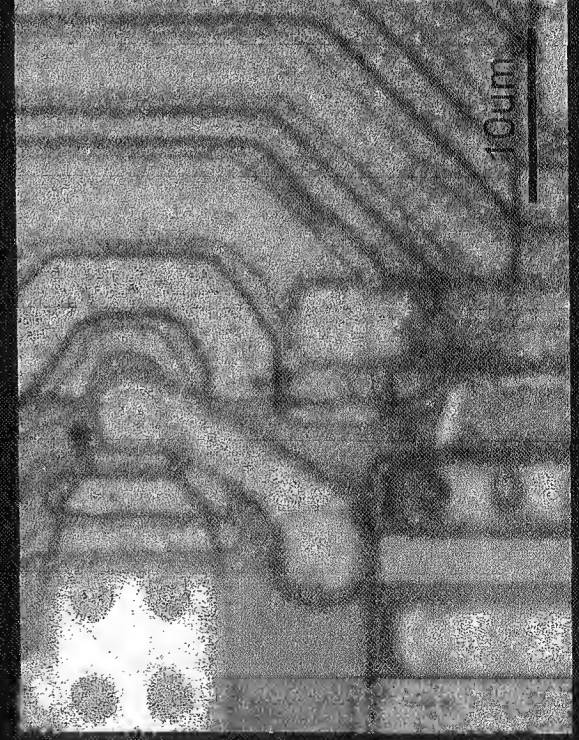
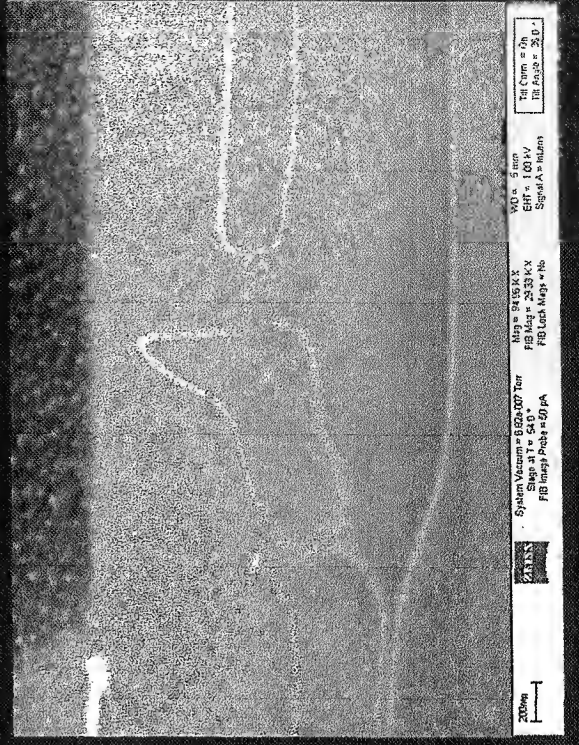
Summary Images

- ESD or line transient
- ..with possible secondary damage caused by IR testing

ECD protection technology and practices used at the test laboratory where these devices are being tested in the application mode is being reviewed to prevent ECD damage to a second set of CCD devices.
